**US Army Corps
of Engineers**

Construction Engineering
Research Laboratories

USACERL Technical Report 95/41
September 1995

Ten-Year Summary and Final Report of Fort Irwin, CA, Family Housing Comparison Test: Operation and Maintenance Costs of Manufactured vs. Conventionally Built Units

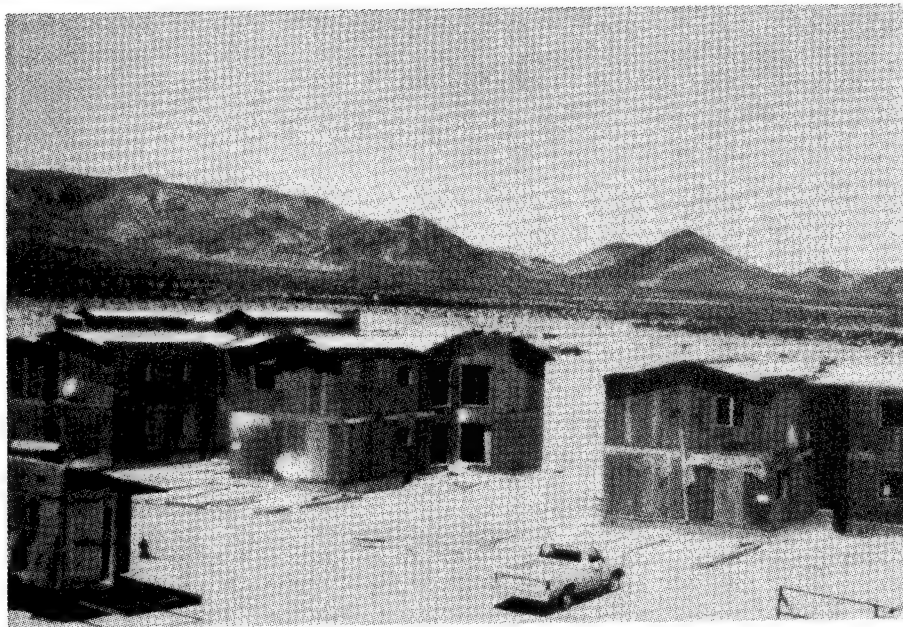
Figure A6. Overview of buildings without garages.
